Final Report
STUDY METHODS TO STANDARDIZE
THERMOGRAPHY NDE

Contract Number: NAS8-38609
Delivery order: 174

February, 1998

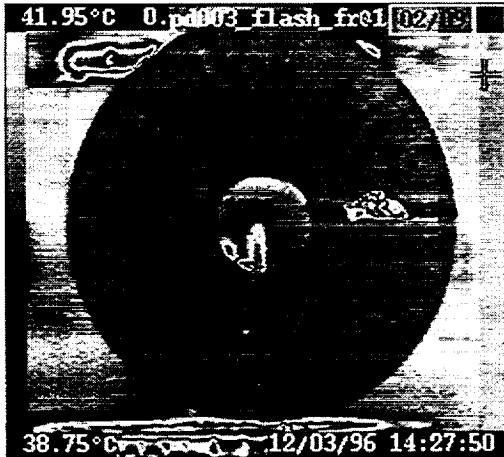
Disk 0180-02-003 (Front)

No thermal abnormalities were detected.

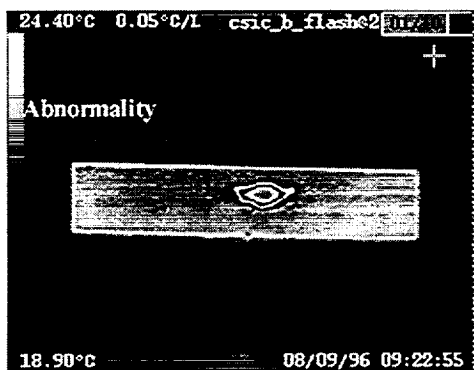
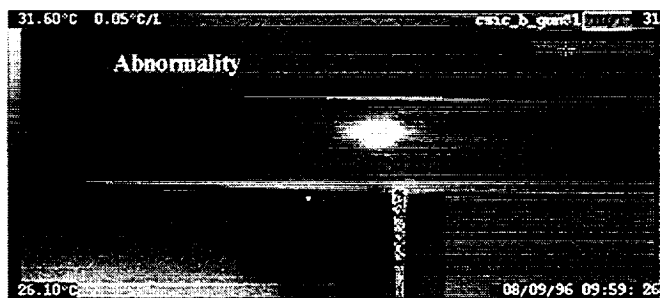
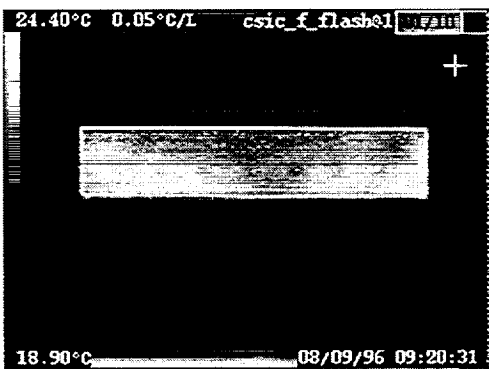
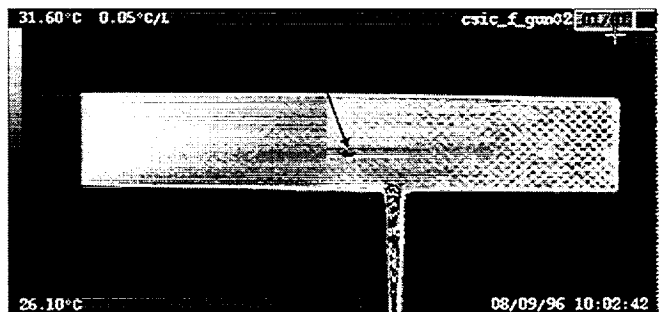
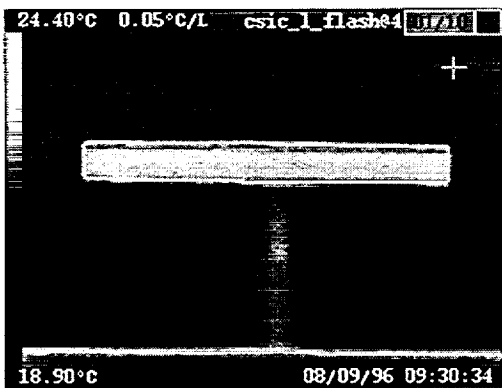
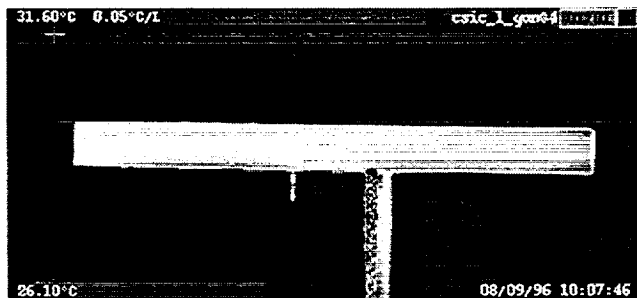
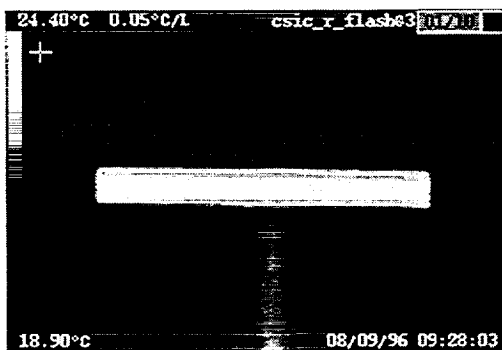
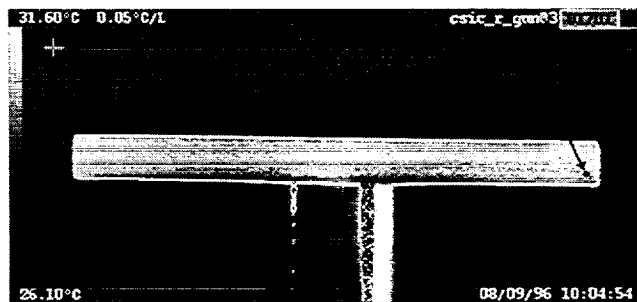
To determine the depth to which the thermographic inspections were penetrating the blisks, a 5.5 by 0.5 by 0.25 inch carbon/silicon-carbide bar was supplied for use as a thermographic defect standard. The bar was inspected using both flash and slow heating before any planned defects were added to determine the initial quality of the bar. As shown in the following figures a large abnormality was found on one face of the bar. It appears that this region is resin starved and may therefore have high porosity.

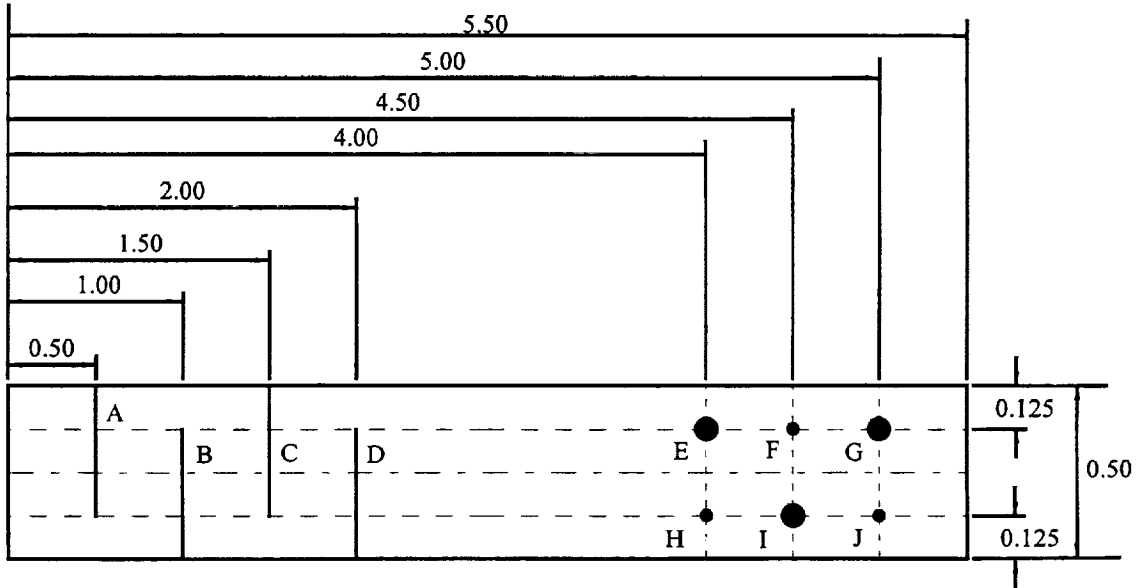
Defects were manufactured by drilling flat bottom holes through to specified depths as shown in the following figure. None of these planned defects were detected using either flash or slow heating. More work will need to be done with the carbon/silicon-carbide material to determine the sensitivity of thermography to detecting defects in that material.

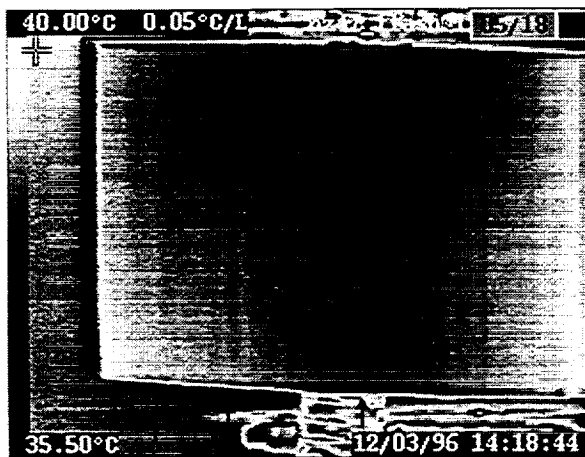
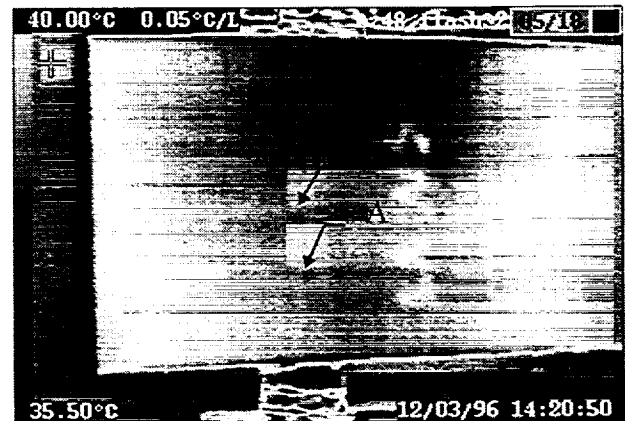
Indications: SN48

Several small thermal abnormalities are evident early in image sequence; two are labeled on thermograms. These abnormalities fade after just a few frames indicating that they are at or very close to surface.

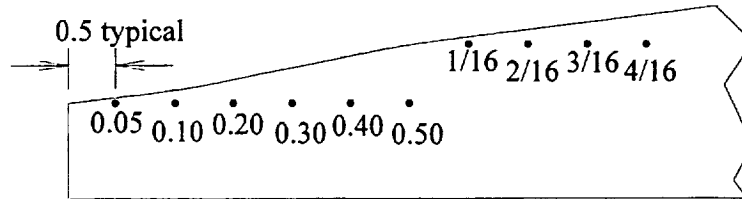
To determine how deep the thermographic inspection was penetrating into the nozzle a series of holes were drilled into the side of Nozzle Segment SN 47. Ten holes, 1/16 inch diameter, were drilled parallel with surface, approximately 1 1/4 inch deep. The holes were drilled 1/2 inch apart at depths of "0.1, 0.2, 0.3, 0.4, 0.5", "1/16, 1/8, 3/16 and 1/4" of an inch from surface.

The only holes which were visible were 1/16 and 0.05 inch below the surface. Since the primary defects of interest were over 1/4 inch deep thermography was ruled out as a viable technique for the inspection of the nozzle segments.

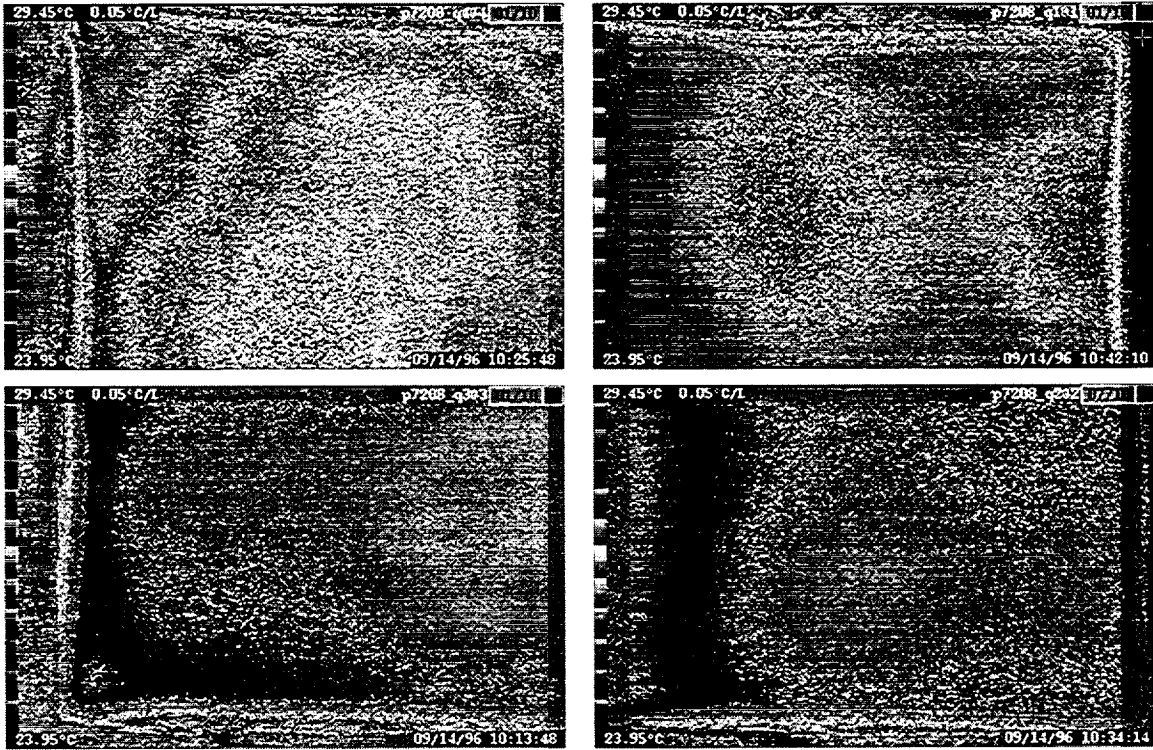
Quadrant Views (4 ft camera to panel)

Three Graphite/Cyanide-Ester tensile test panels were inspected for the X-33 project. The panels were all heated from the back surface with 2 - 500 W quartz heat lamps. The frame delay for each inspection was set to 0.5 sec per frame and the camera to part distance for full view set to 70" and 30" for section views. In all cases no thermal abnormalities detected.

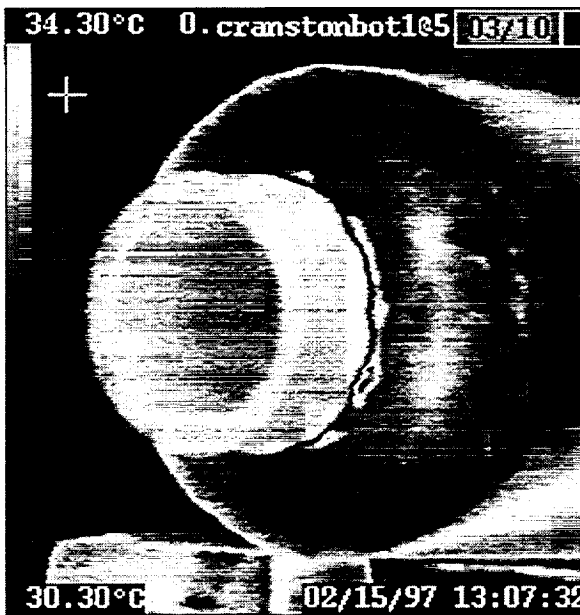
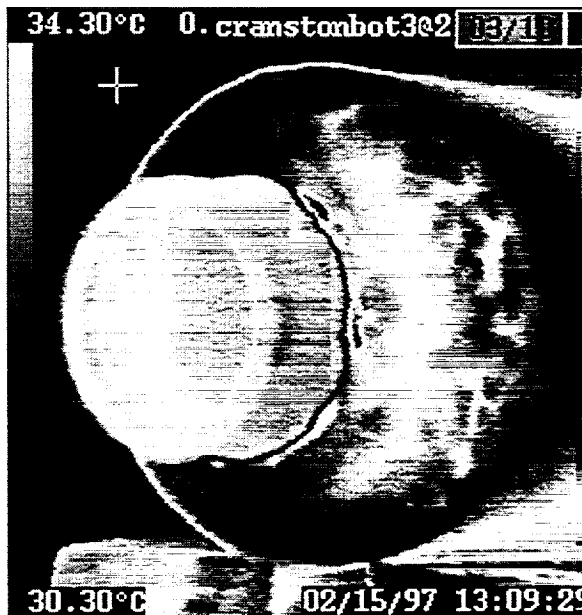
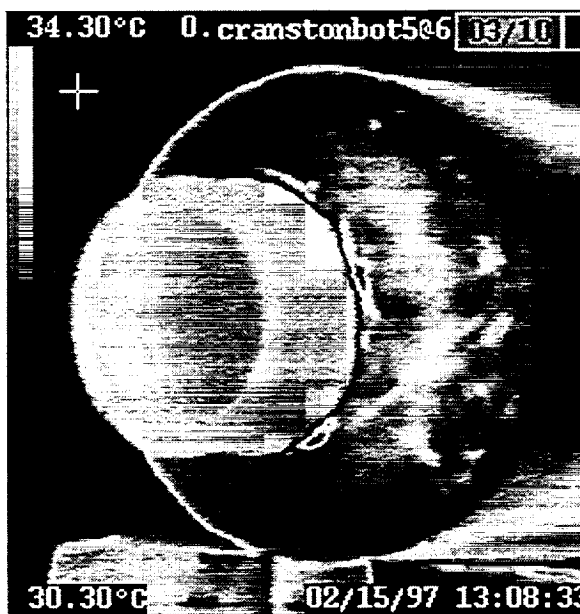
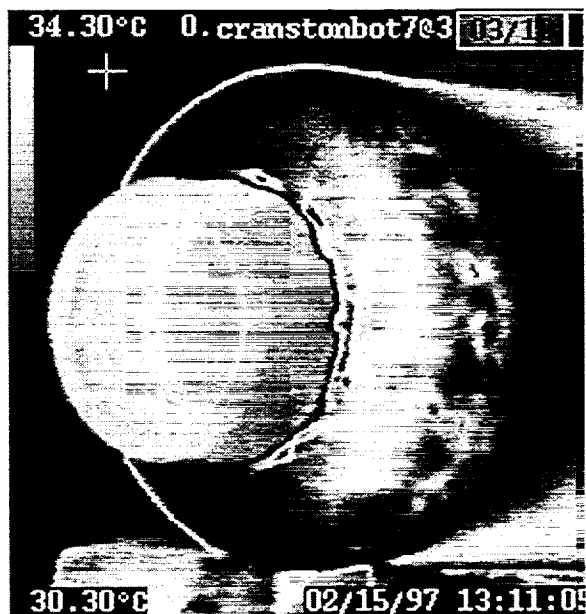
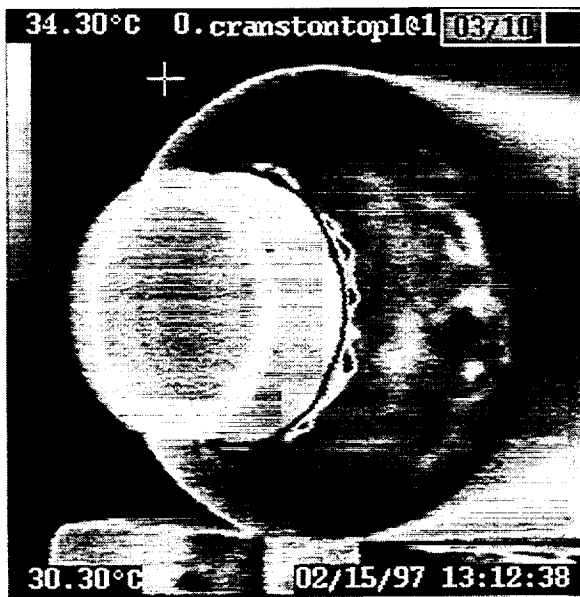
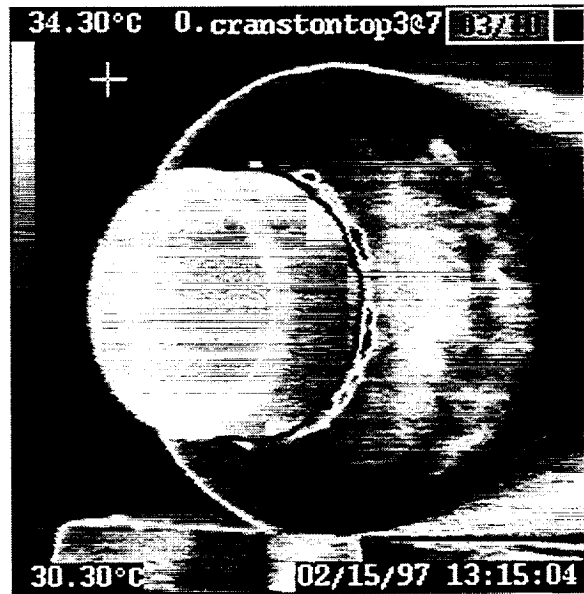
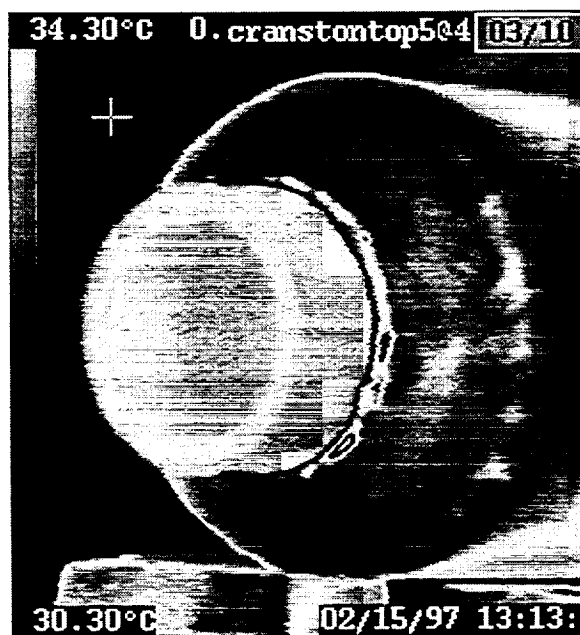
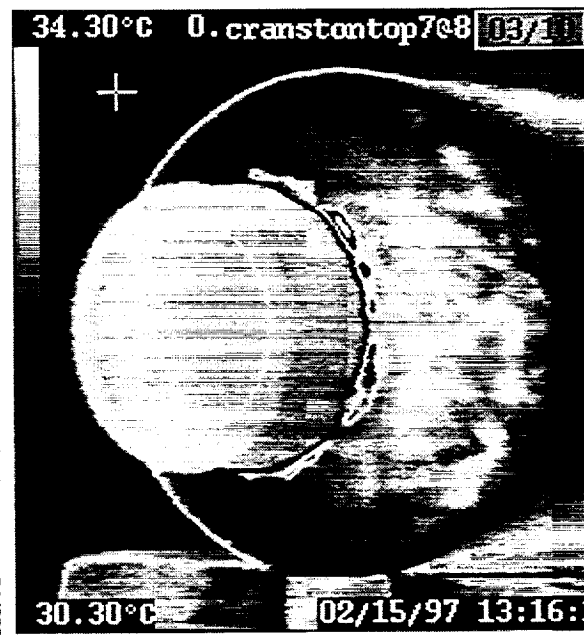
The end and quarter end views of the vessel shows the same sort of thermal abnormalities as the side views. Small hot regions of potential disbonded shell can be seen to extend all the way around the end of the vessel.

It should be noted that these some of the thermal abnormalities shown may be due to sources other than disbonds, such as resin rich/starved regions, nonuniformity of the inner liner or porosity in the shell itself. To confirm the source of the thermal abnormality a vessel would need to be thermally inspected then dissected.

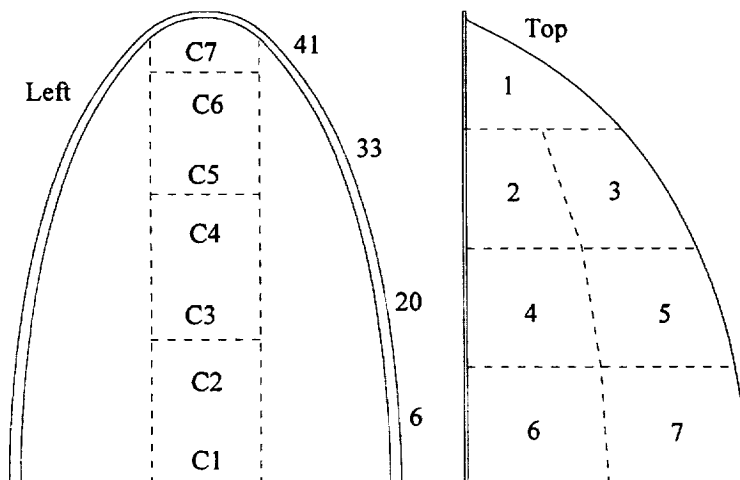
The thermographic inspection yielded 13 potential regions of porosity, including the six previously located by ultrasonics. The following figure outlines the six regions found by UT and the 13 found by thermography. These thirteen regions are also shown on the resulting thermograms.

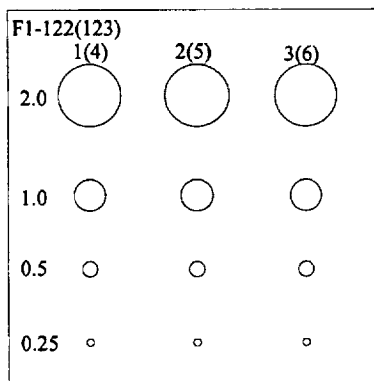
Panel F122/123 Panel F122/123 was created at JSC to investigate methods to simulate disbonds between the faceplates and core. The panel featured 15 ply, graphite/cyanide-ester faceplates on a nomex honeycomb core. The defects are identified in the following figure.

| 2. Missing cobond adhesive | 5. Teflon insert |
| 3. Release agent | 6. Missing adhesive filled with cured adhesive |

The results of these tests revealed that only the 2.0, 1.0 and 0.5 inch diameter “missing cobond adhesive” defects were identifiable during flash heating. No thermal indications were found using either front or back side manual heating. In fact it was noticed that it was very difficult to get heat through the panel during manual back side heating. Image filtering through convolution with a simple edge enhancement filter helped to identify the defects

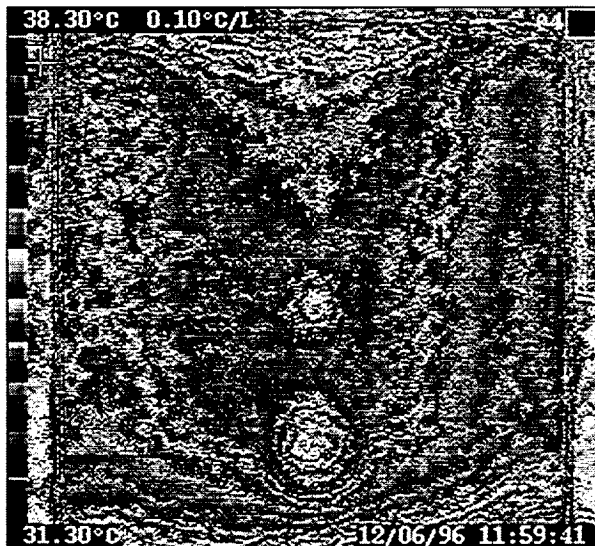
F122 Filtered

F122 (Missing cobond adhesive defects)

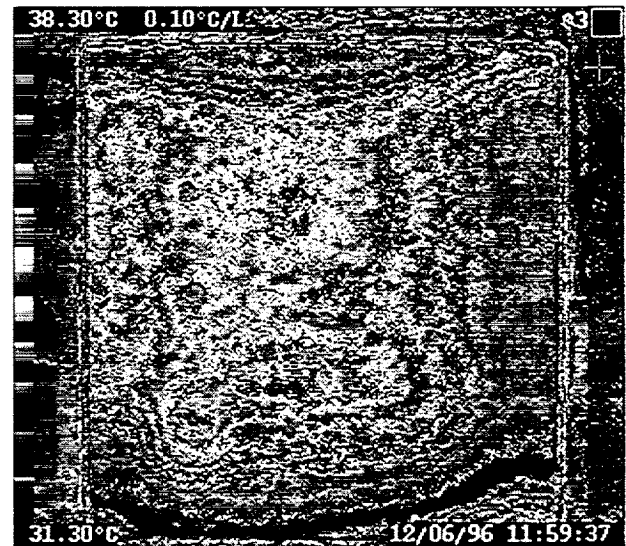
F123 Filtered

F123 (Cured adhesive inserts)

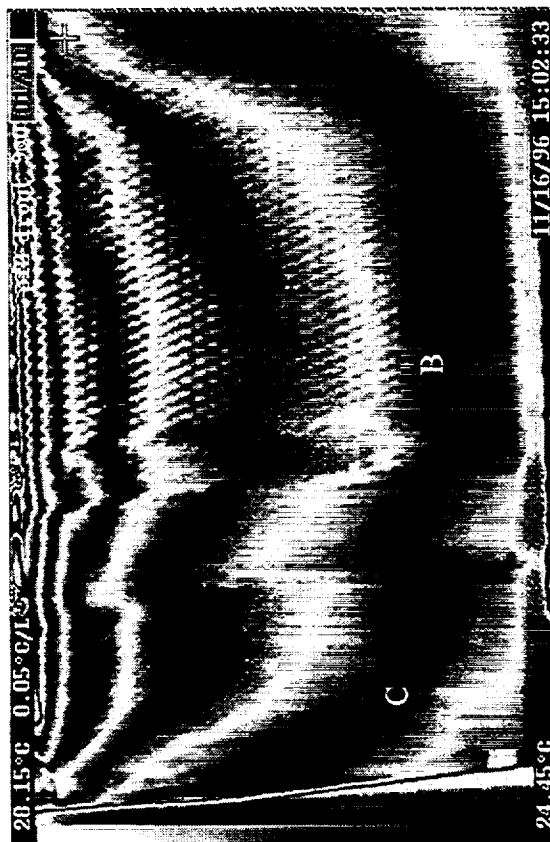
Front 9

The thirteen regions shown in images Front 4, 6 and 9 along with images Back 2, 7, 9 and 10 represent the worst of the thermal abnormalities found. These thermal indications had little or no surface features.

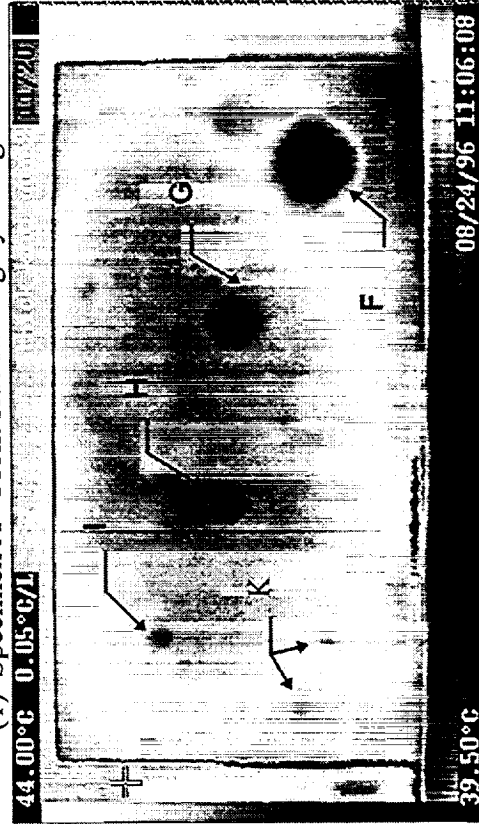
(3) Specimen C - Front side heating by heat gun

Specimen C is seen in images 3, 4 and 6. In images 3 and 4 a heat gun was used for the thermal excitation and the time delay set to 1 sec/frame. Image 6 was acquired with flash heating and time delay of 0.5 sec/frame. It is interesting to see that the flash imaged flaws are better defined than those obtained with manual heating, but not all flaws are found with flash heating.

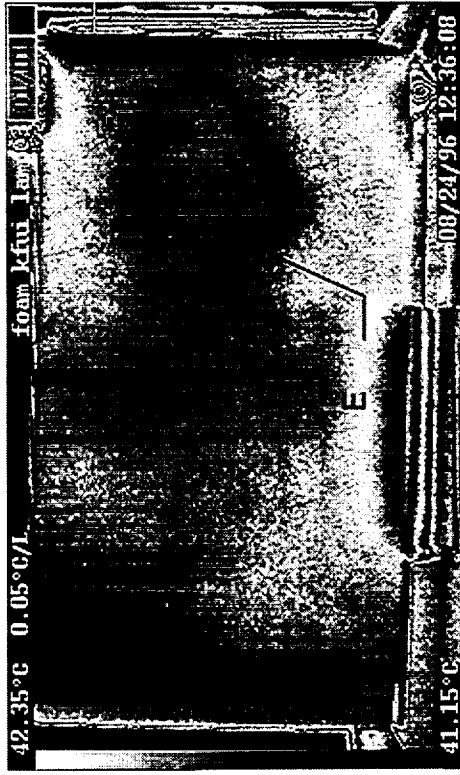
Specimen B had inserts in the same position as specimen A. Image 2, produced by back side long duration heating by 2 - 500W heat lamps only showed the largest of these two defects, as one defect. No other heating method produced as good a results as the back side heating used for this image.

(2) Specimen B - Back side heating by 2-500 W lamps

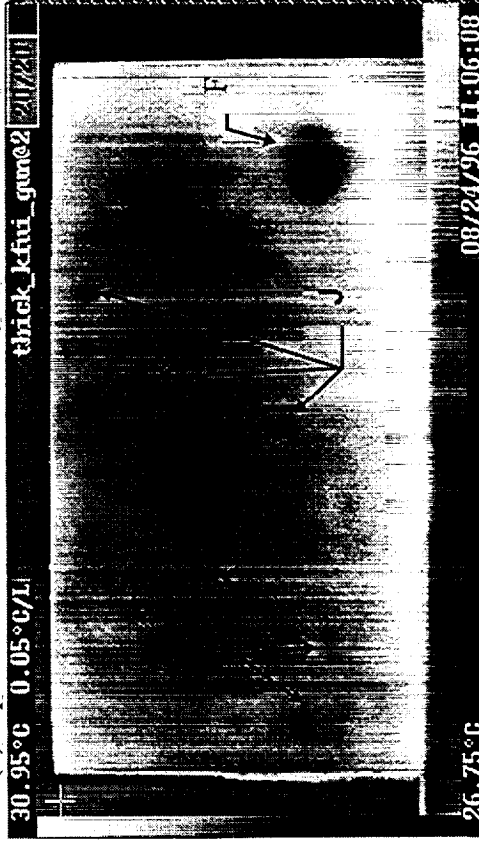
(4) Specimen C - Front side heating by heat gun

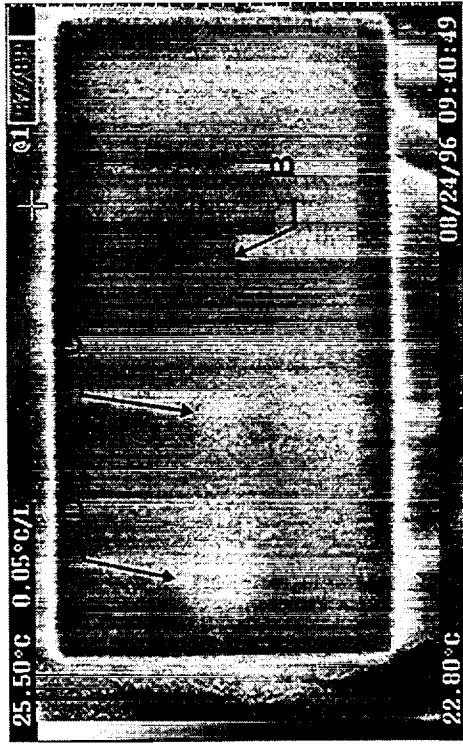
Image 1 was acquired with front side heating by a hand held heat gun. The time delay between images was set to 100 msec and images 2 through 21 were archived. In this image all four scheduled defects can be seen. When specimen A was excited with flash heating only the largest three defects could be found.

(5) Specimen A - Flash lamp heating

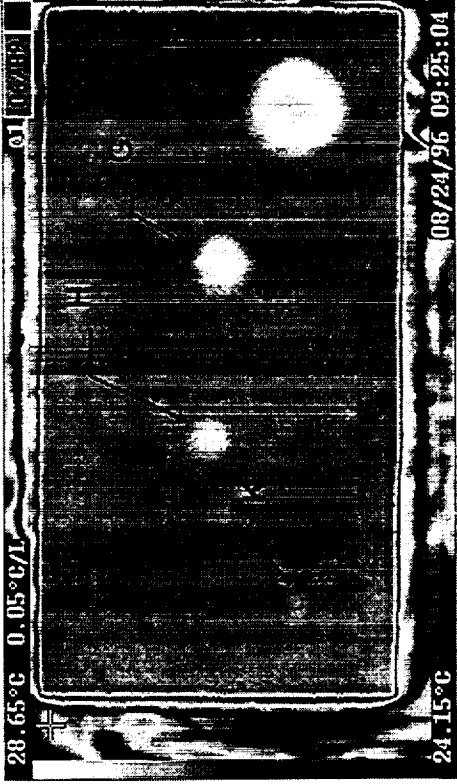
(6) Specimen C - Flash lamp Heating

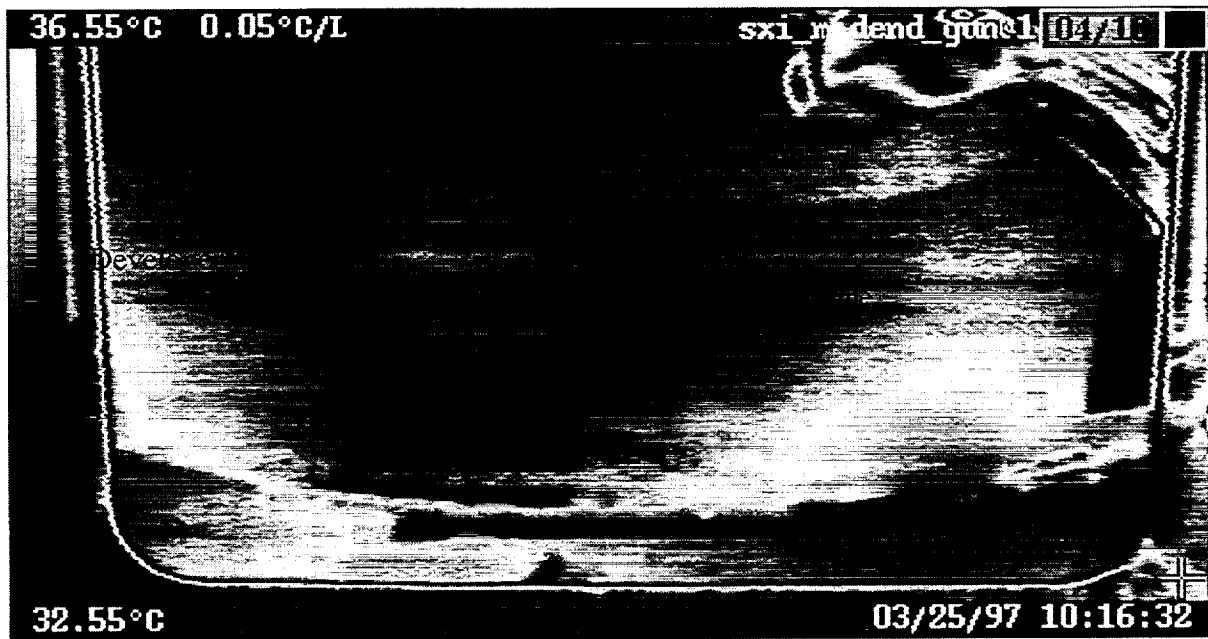
The images (both flash and manual heating) of where attachment pad 1 and 2 tore loose clearly show the regions where the tube delaminated upon failure. It was difficult to view the bondline during flash heating. During manual heating though, several discontinuities can clearly be seen. These discontinuities may be cracks "delaminations" formed due to the bending moment applied to the joint when the upper pads failed. The joint would need to be inspected with other NDE techniques such as ultrasonics or x-ray to verify these conclusions.

Mid-attach points (Heat gun)

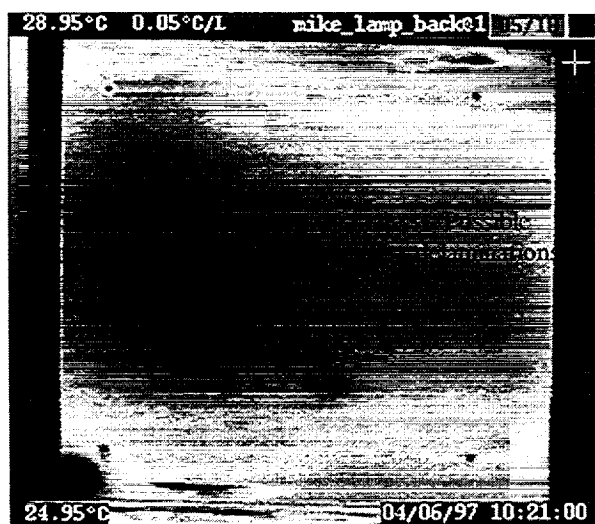
(5) Backside

Each bolt hole shows some degree of damage. The upper right hand bolt hole appears to be in the worst shape, with delaminations running approximately 1/4 inch up and down the panel.

There also appears to be some form of subsurface feature below the visible surface wrinkle on the top of the panel. Without a reference standard it is difficult to tell if the thermal inspection is reaching the core/faceplate interface.

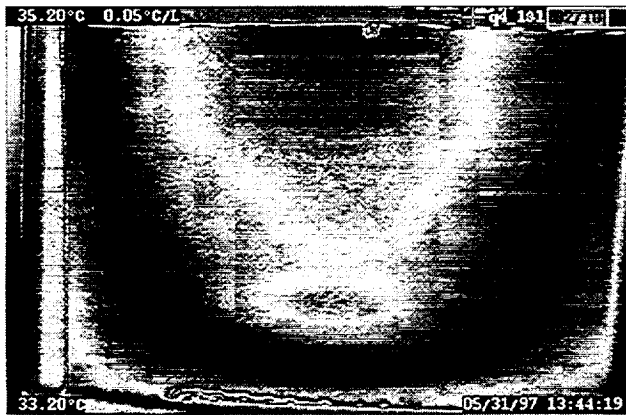
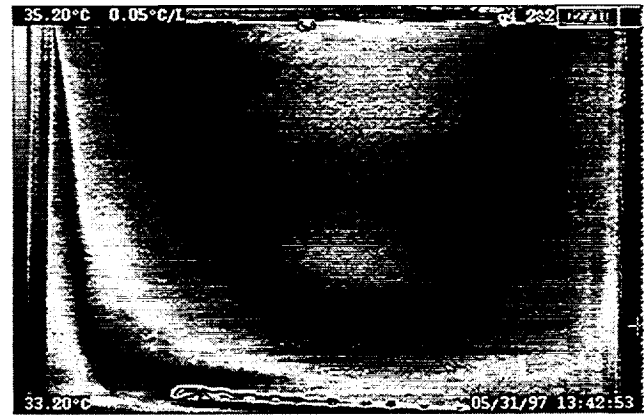
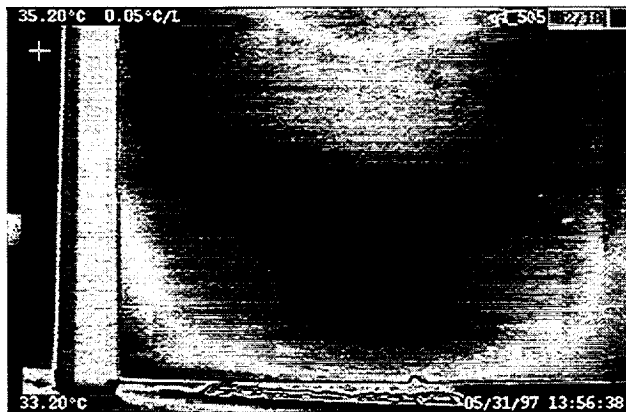
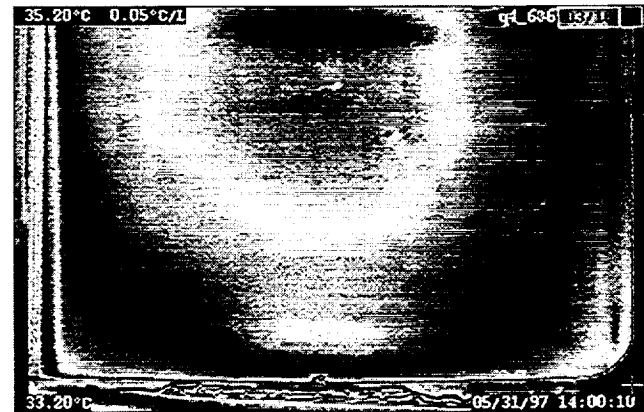
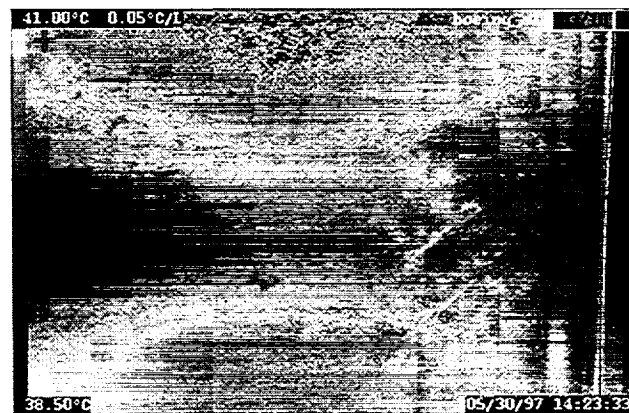
5.14 Thermography Of Space Station Rack Rear Access Panel (Q4)

- Good correlation with porosity region detected by UT.
- Porosity not detectable from front surface scan of rack.

Close-up of porosity
